# State of Nevada Division of Water Resources

## Water Level Data Chart

Graph #1, MX-107  
HA 173 B, Railroad Valley  
3.1 Foot Decline.

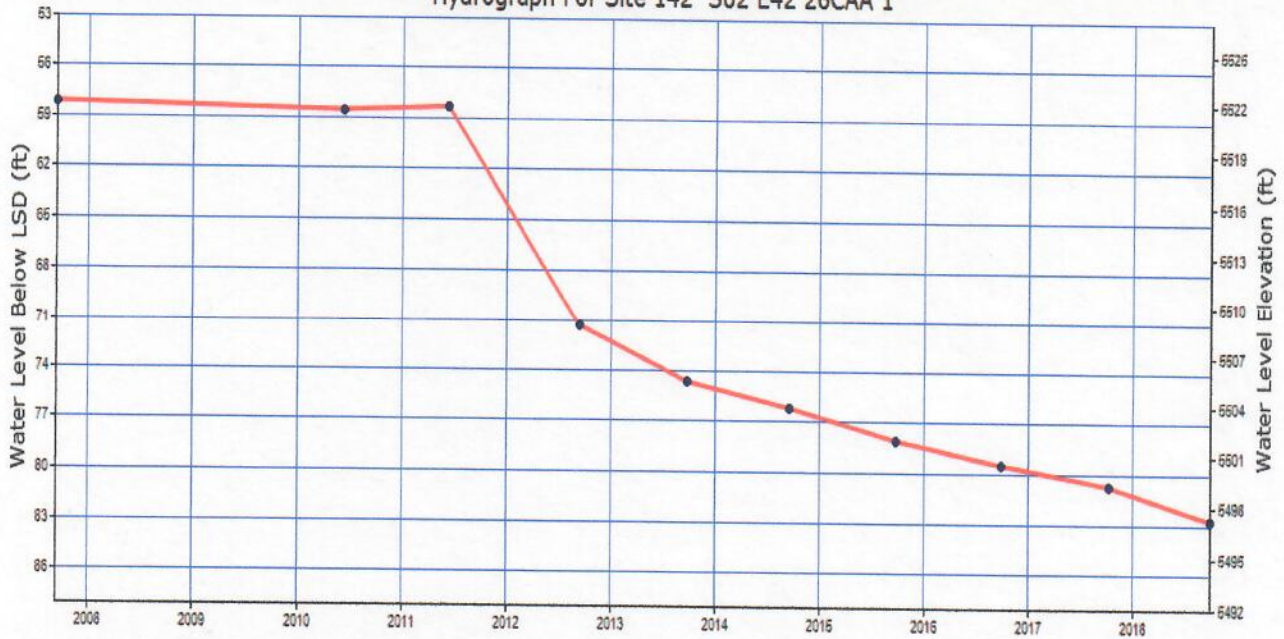
Hydrograph For Site 142 S02 E42 26CAA 1

Graph # 3. Goldfield Mine Well  
HA 142. Alkali Springs Valley  
24.6 Foot Decline.

06/10/2011	58.33		5521.67	Electric Tape	WELL BEING TESTED BY ENG. FIRM. CNRWA WATER LEVEL			
06/10/2010	58.56		5521.44	Steel Tape	CNRWA water level			
09/13/2012	71.3		5508.7	Steel Tape	Well equipped and appears to be pumped periodically			
09/22/2013	74.62		5505.38	Steel Tape	May be pumped periodically			
09/15/2014	76.18		5503.82	Electric Tape	CNRWA measurement			
09/23/2015	78.1		5501.9	Electric Tape	CNRWA measurement.			
09/25/2016	79.51		5500.49	Electric Tape	CNRWA measurement.			
10/05/2017	80.73		5499.27	Electric Tape	CNRWA msmt ,			
09/25/2018	82.74		5497.26	Electric Tape	CNRWA msmt.

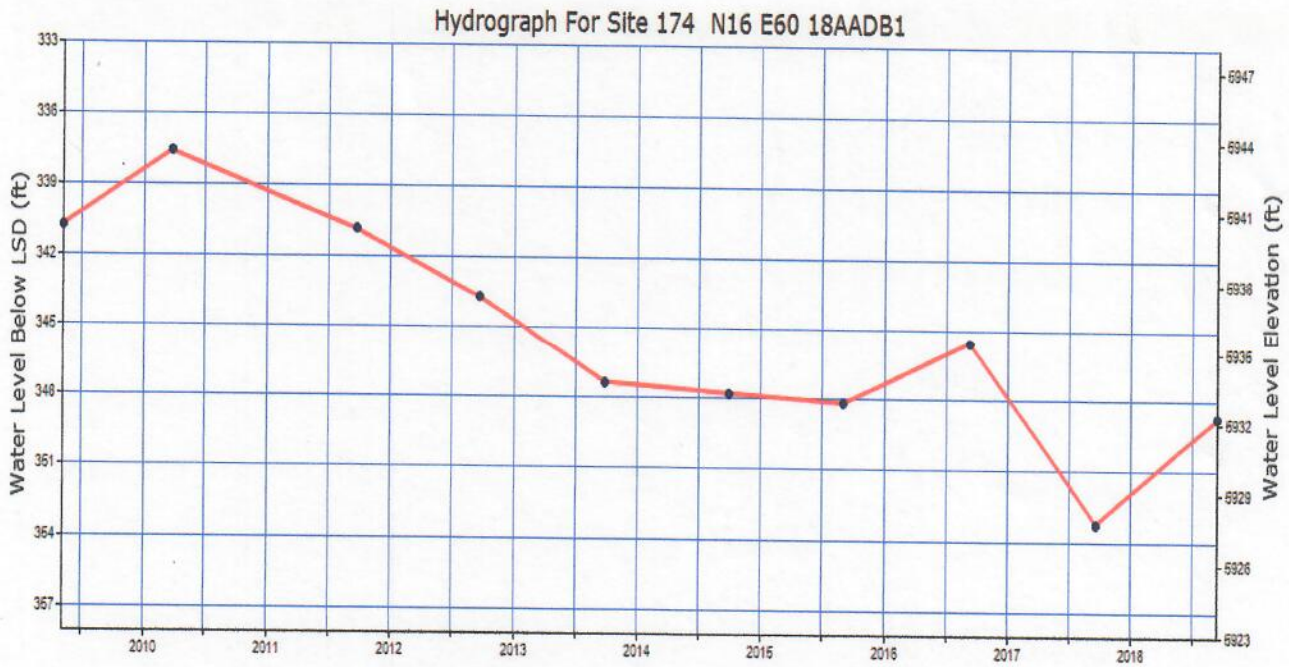
# Jakes Valley Well

Graph # 4. Jakes Valley Stock Well.  
HA 174. Jakes Valley  
4.4 Foot Recovery

Home	News	Forms	Water Rights	Programs	Mapping & Data	Hearings	FAQ	Calenda	≡
	<del>09/18/2017</del>	<del>353.22</del>		5927.70	Electric Tape	CNRWA	INSITE		
	09/08/2016	345.55		5935.45	Electric Tape	CNRWA	measurement.		
	09/02/2015	348.18		5932.82	Electric Tape	CNRWA	measurement.		
	09/27/2014	347.8		5933.2	Electric Tape	CNRWA	measurement, Heavy rain in valley night before		
	09/25/2013	347.35		5933.65	Electric Tape	CNRWA	water level		
	09/19/2012	343.7		5937.3	Electric Tape	CNRWA	water level		
	09/20/2011	340.84		5940.16	Electric Tape	CNRWA	water level		
	03/23/2010	337.59		5943.41	Electric Tape	CNRWA	water level		
	05/06/2009	340.72		5940.28	Electric Tape	USGS	WATER LEVEL
