# State of Nevada Division of Water Resources

## Water Level Data Chart *Graph #1. MX-107*

## Water Level Data Chart *Graph #2. Silver Peak WO-2.*

## Water Level Data Chart *Graph #3 Goldfield Mine Well*

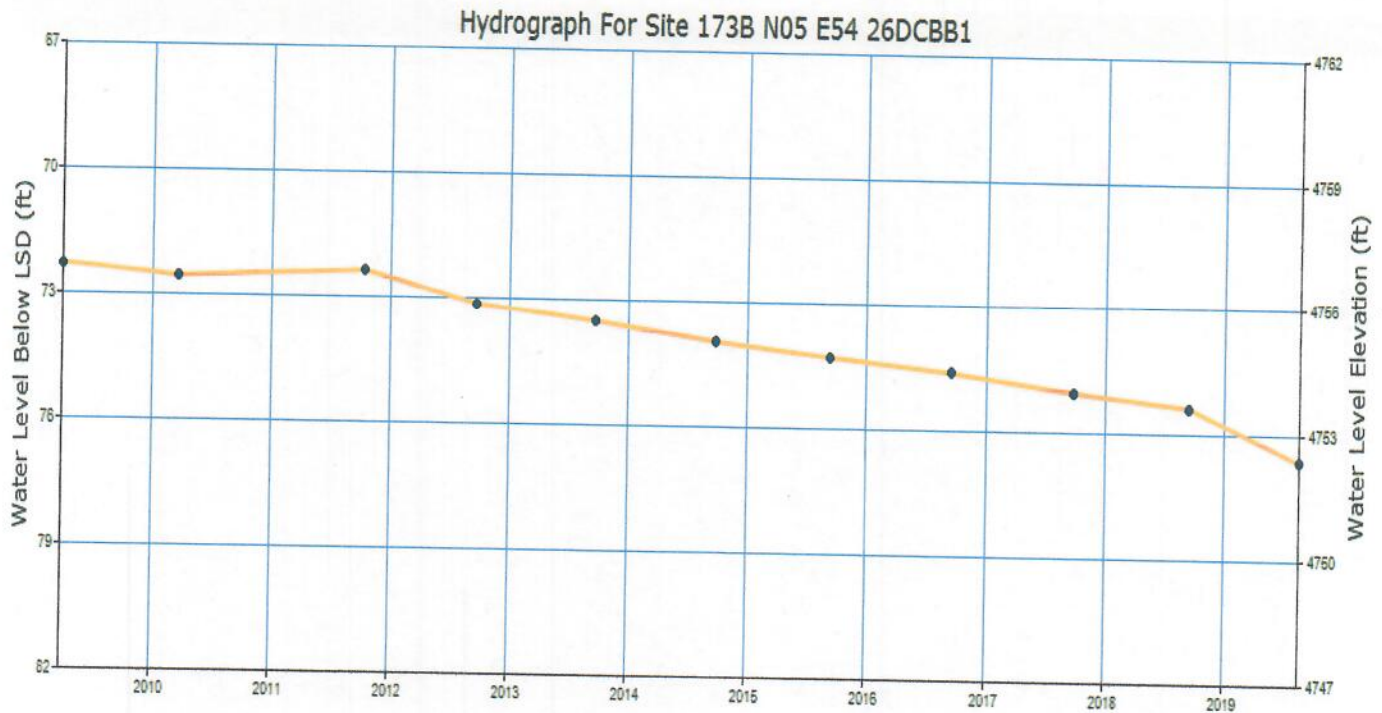
MX-107

8-22-19 76.75'

9-30-20 Well destroyed. Sanded-in 200' back to 64'

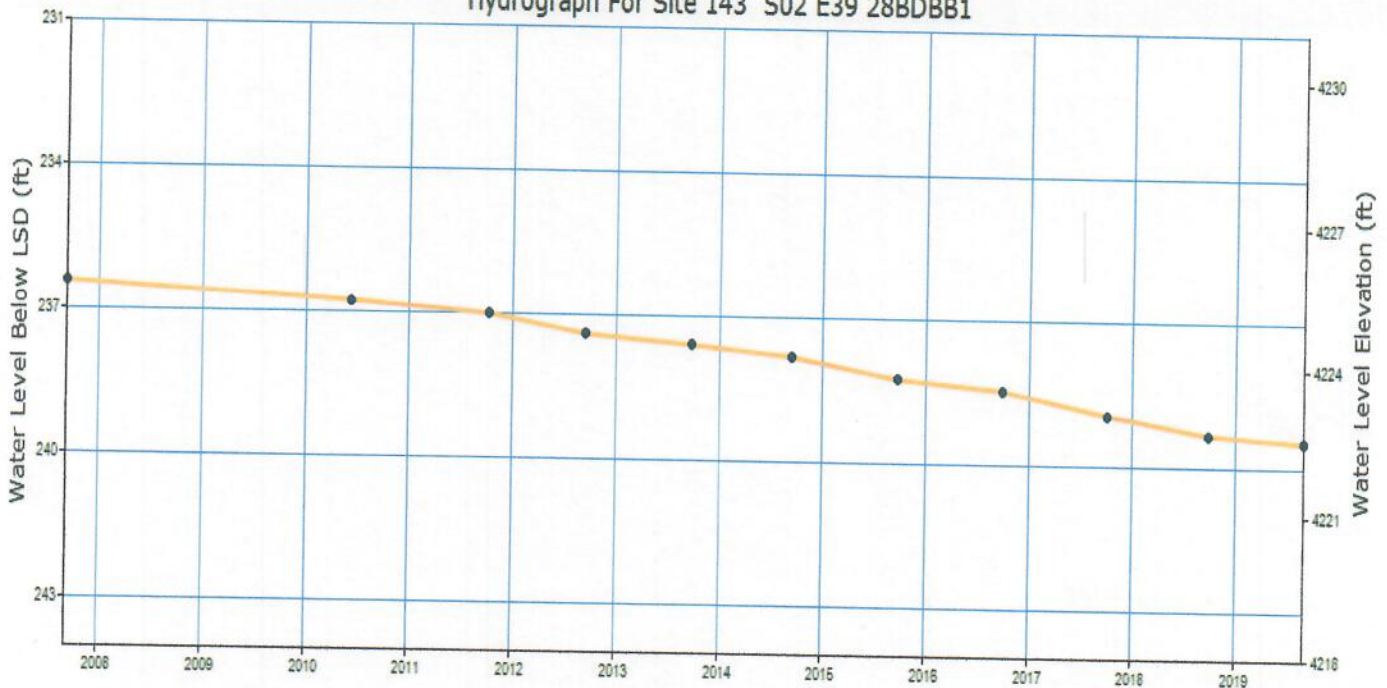
Hydrograph For Site 143 S02 E39 28BDBB1

8-30-19 239.5'

10-15-20 239.7'

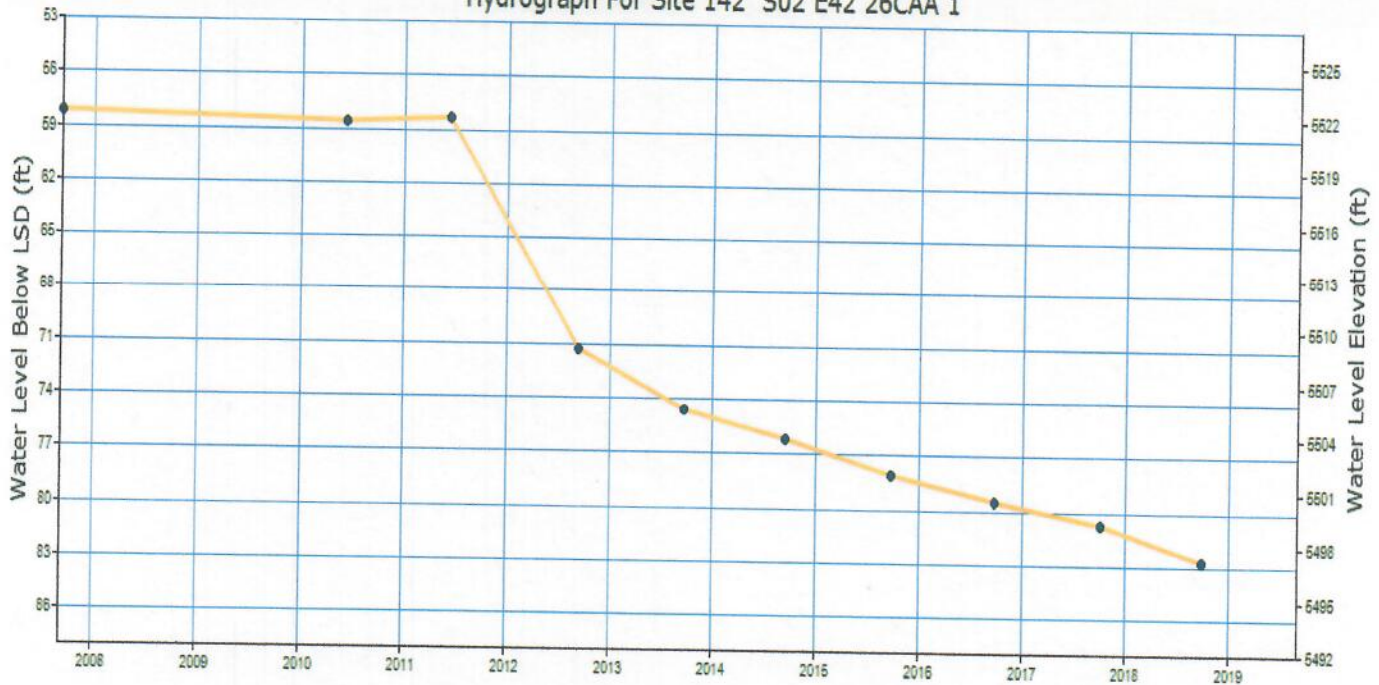
Hydrograph For Site 142 S02 E42 26CAA 1

| Measure Date | Depth To Water | Water Surface Elevation | Method | Comments |
|---|---|---|---|---|
| 09/22/2013 | 74.62 | 5505.38 | Steel Tape | May be pumped periodically |
| 09/13/2012 | 71.3 | 5508.7 | Steel Tape | Well equipped and appears to be pumped periodically |
| 06/10/2011 | 58.33 | 5521.67 | Electric Tape | WELL BEING TESTED BY ENG. FIRM. CNRWA WATER LEVEL |

10-15-20 No access - Right of Way Fenced

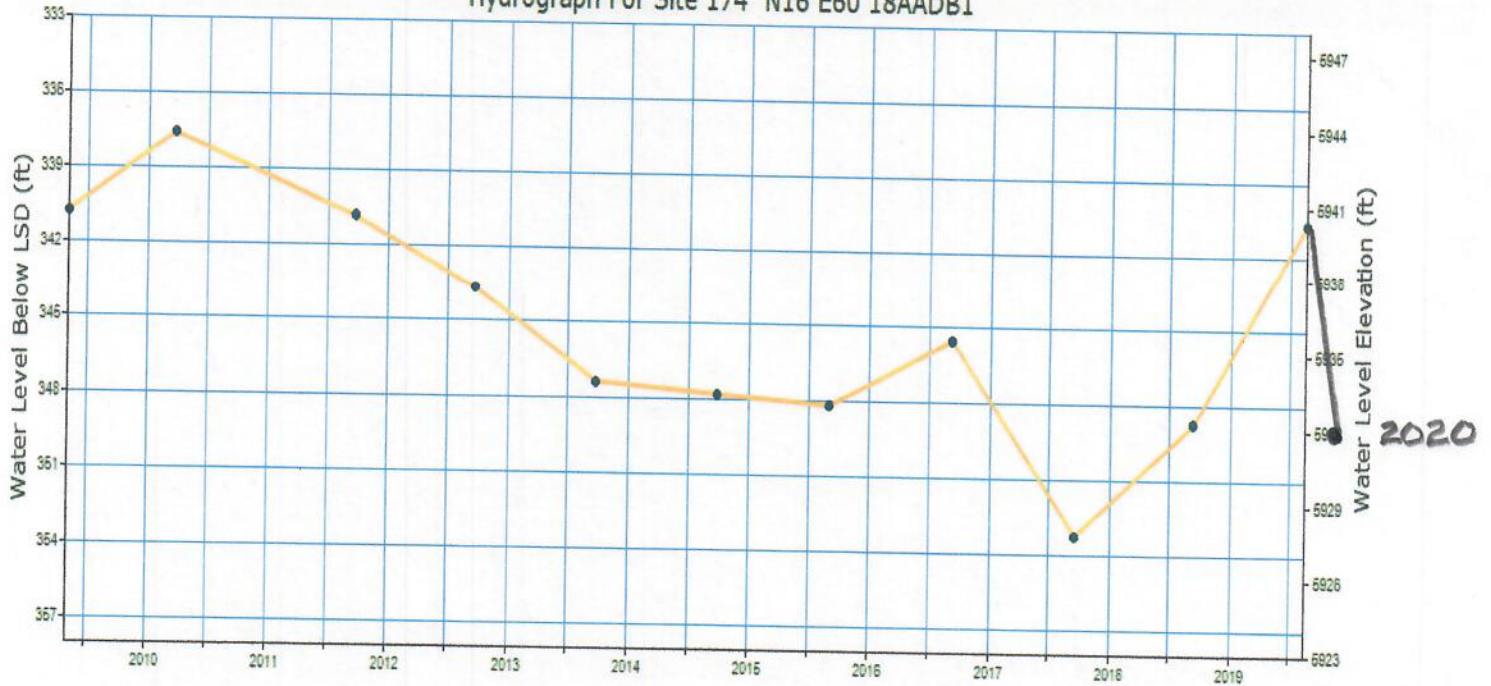
Hydrograph For Site 174 N16 E60 18AADB1

## Water Level Data Chart *Graph # 4 Jakes V. Stock Well*

| Measure Date | Depth To Water | Water Surface Elevation | Method | Comments |
|---|---|---|---|--|
| 09/27/2014 | 347.8 | 5933.2 | Electric Tape | CNRWA measurement, Heavy rain in valley night before |

9-20-20

349.1'

8-15-19

340.7'
