## Water Level Data Chart

MX 107

# State of Nevada Division of Water Resources

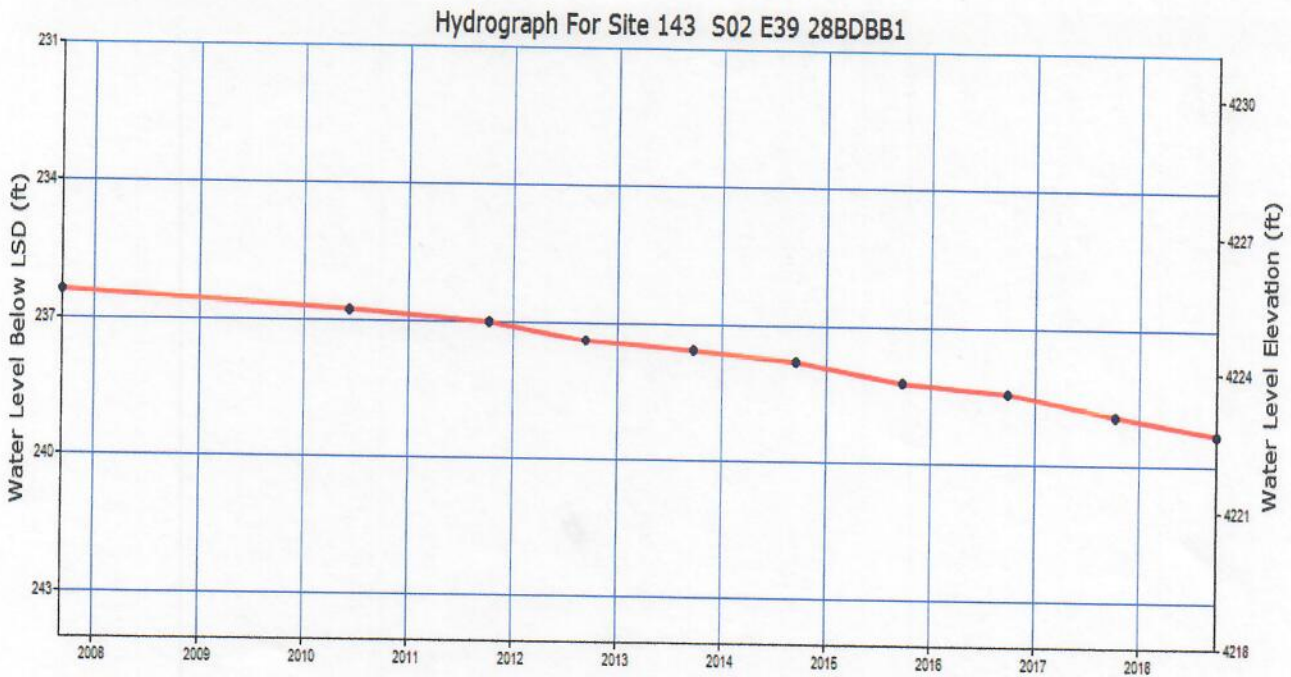
## Graph # 2.

## Silver Peak WO-2

Measure Date	Depth To Water	Water Surface Elevation	Method	Comments
09/25/2018	239.34	4222.66	Electric Tape	CNRWA msmt.
10/05/2017	238.95	4223.05	Electric Tape	CNWRA msmt
09/26/2016	238.47	4223.53	Electric Tape	CNRWA measurement.
09/24/2015	238.26	4223.74	Electric Tape	CNRWA measurement.
09/15/2014	237.83	4224.17	Electric Tape	CNWRA measurement
09/23/2013	237.61	4224.39	Electric Tape	CNRWA water level
09/13/2012	237.41	4224.59	Electric Tape	CNRWA water level
10/11/2011	237.02	4224.98	Electric Tape	CNRWA water level
06/10/2010	236.77	4225.23	Electric Tape	CNRWA water level. New M.P.
09/10/2007	236.4	4225.6	Electric Tape	USGS WATER LEVEL

8-30-19 239.49
